SERMA TECHNOLOGIES

**ANALYSIS ON EXTERNAL LEADS
OF DPD DIODES
FROM HAMAMATSU
REPORT E02P1865 - JANUARY 13, 2003**

**CEA Saclay
Bât. 709 - DAPNIA /SAP
91191 GIF-SUR-YVETTE**

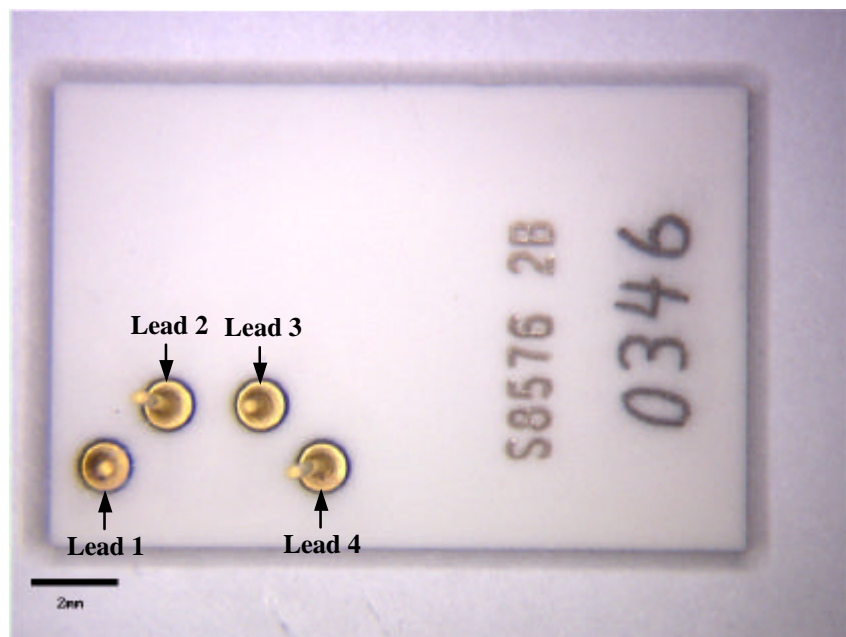
Figure 1. General view of one DPD diode, Part 346, mag $\approx 5X$.

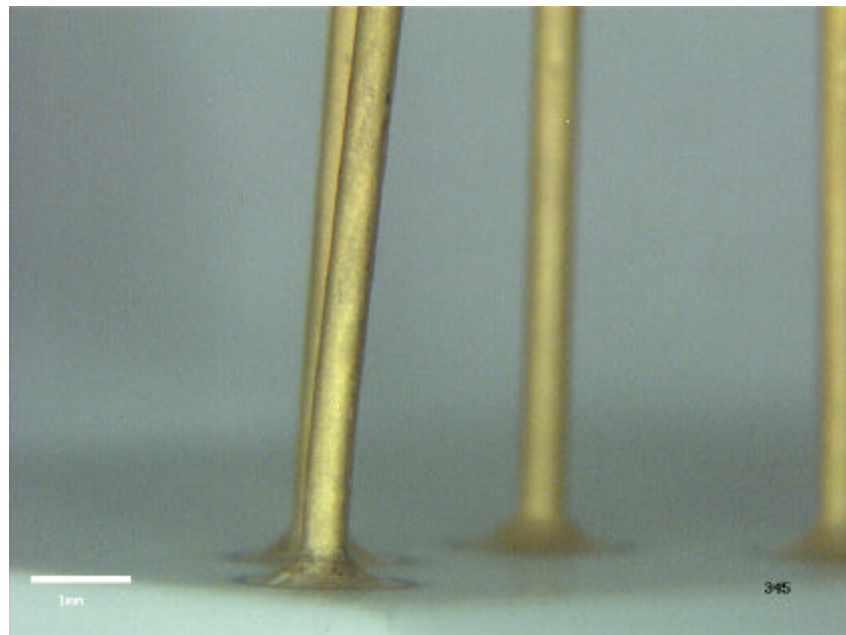
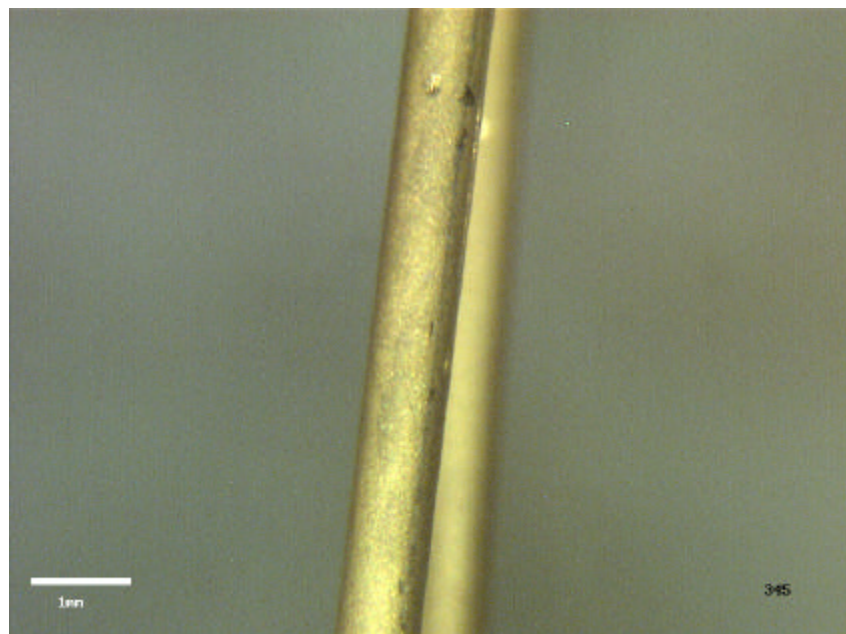
- A general view of one part with leads reference is shown in Figure 1.
- A few Au layer discolourations were observed on one lead of the DPD diodes referenced 336, 345, 346 and 358 (Figures 2 and 3).
- Au layer was chemically removed (Au etch solution) from the leads on the DPD diodes referenced 345 and 358. No anomaly was detected at the discoloured areas previously observed.
- Nevertheless, two corrosion points were observed on one lead of the DPD diode referenced 345 (Figures 4 to 6).
KOVAR basis material was visible on one corrosion point.
O element was detected at the corrosion level (Figure 7).

Figure 2. Optical views of external leads, Part 345.
Top : mag $\approx 15X$; bottom : mag $\approx 30X$.

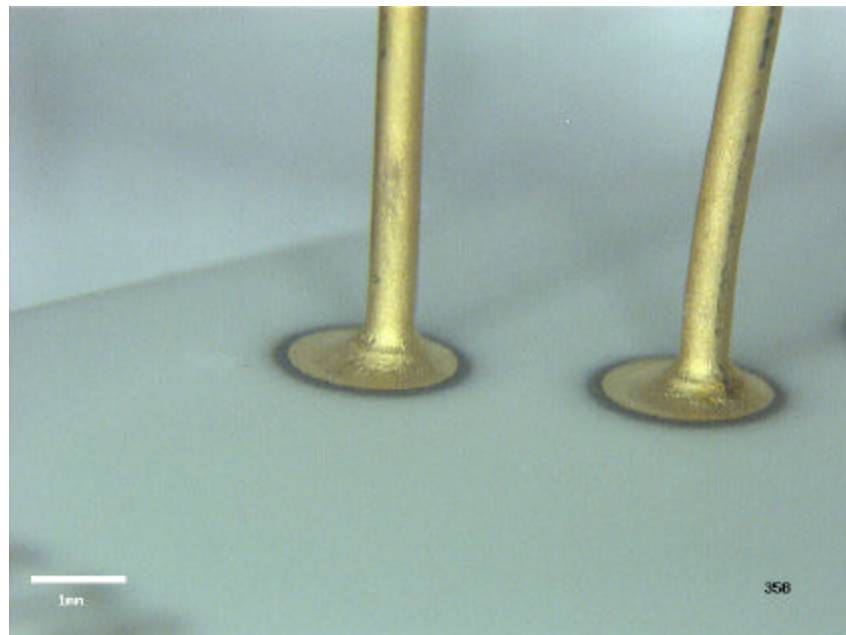
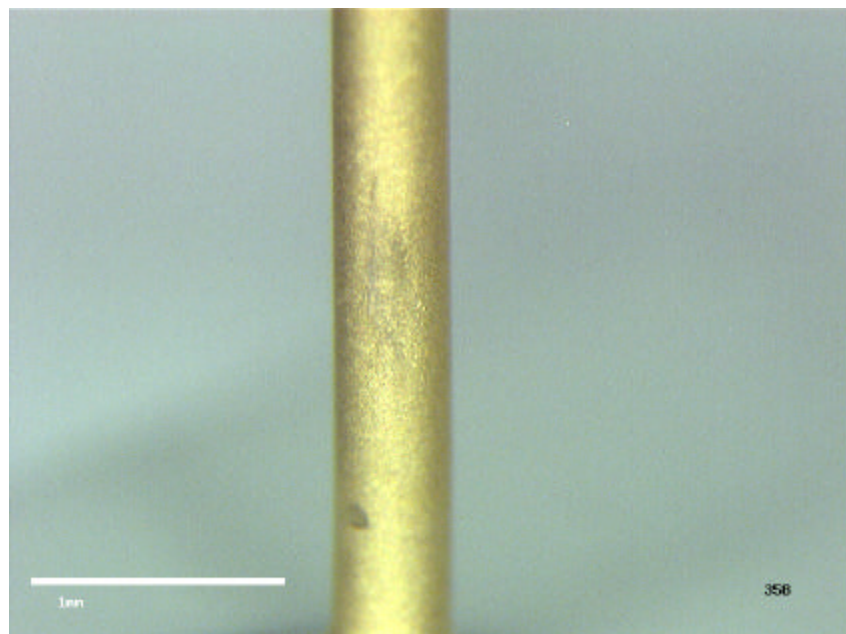
Figure 3. Optical views of external leads, Part 358.
Top : mag $\approx 15X$; bottom : mag $\approx 35X$.

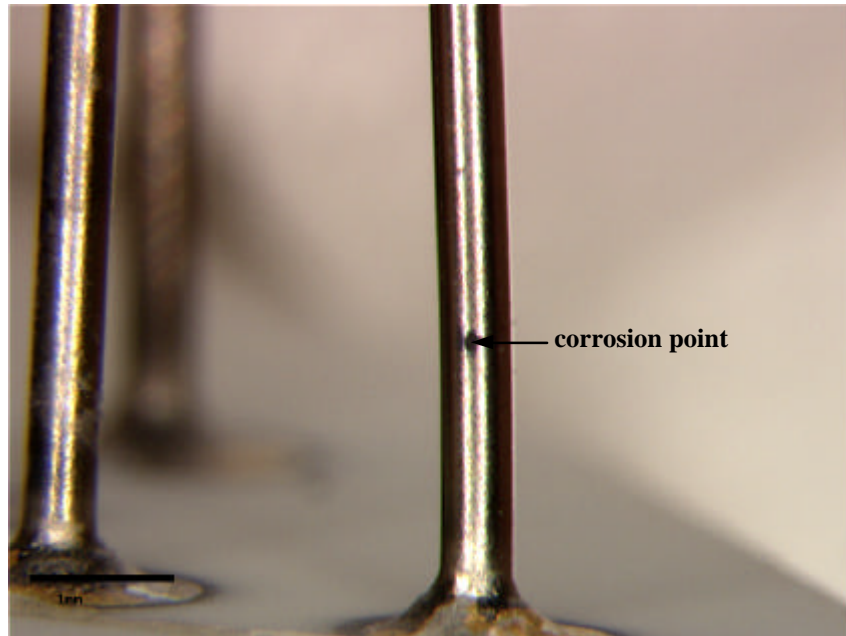
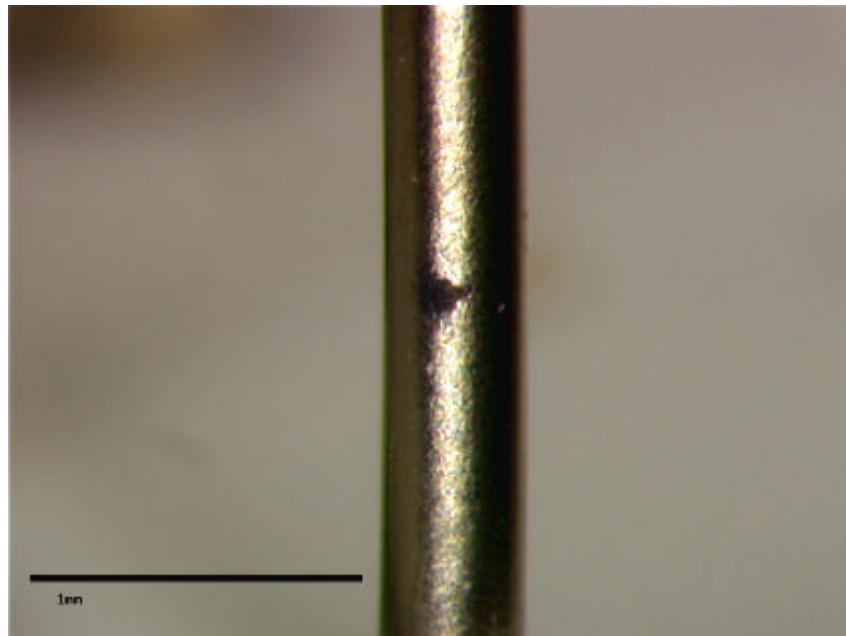
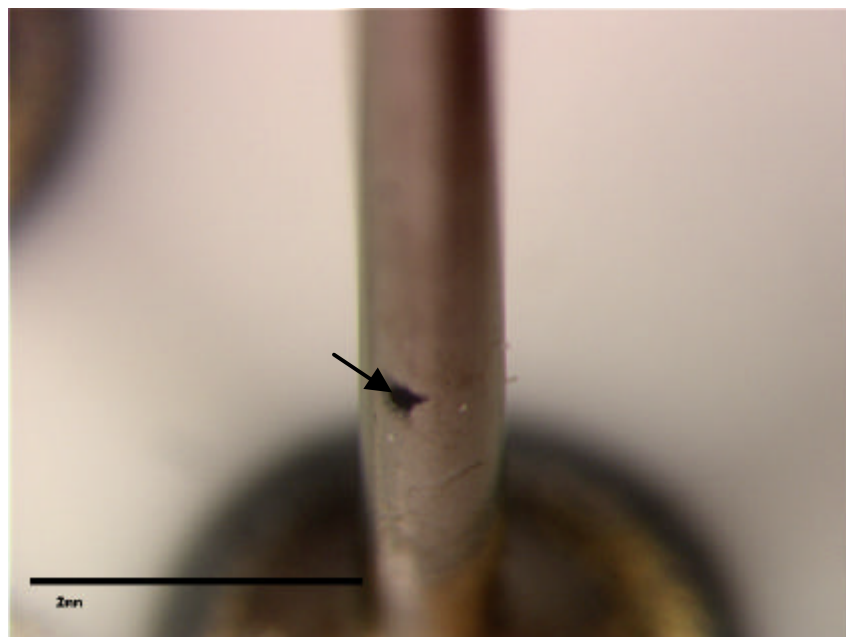
Figure 4. Optical views of external leads after Au layer removal, Part 345.
Top : mag $\approx 21X$; center and bottom : mag $\approx 45X$.

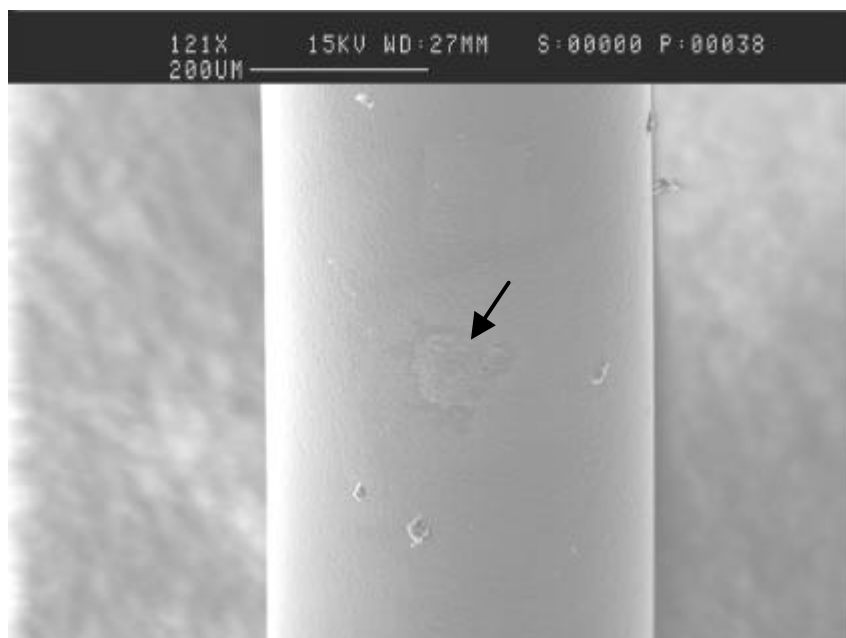
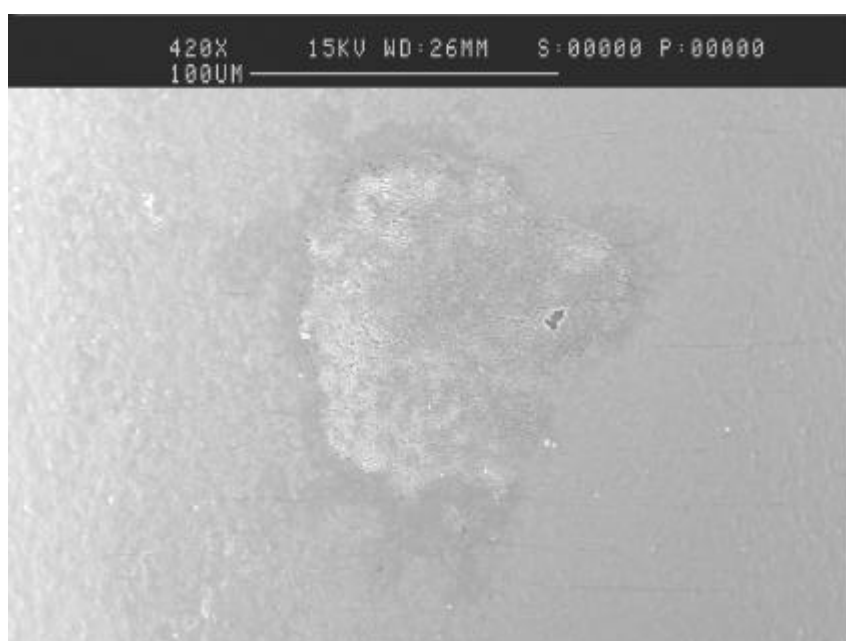
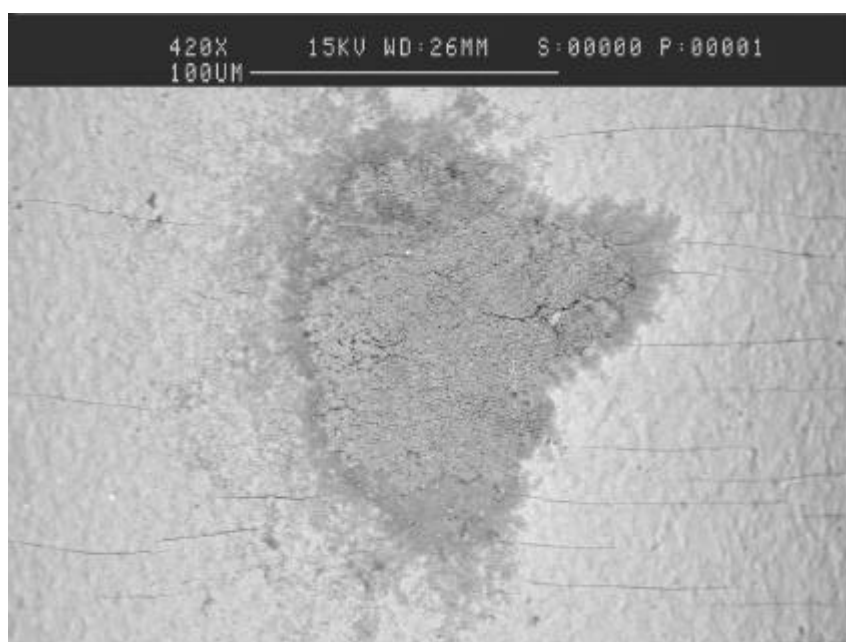
- * Two corrosion points were detected on one lead (lead 1) of the DPD diode referenced 345 after Au layer removal (it did not concern the same lead that on the previous report). This corrosion was located at the KOVAR / NiP layer interface.
- * This corrosion occurred during the ceramic package manufacturing before the NiP and Au layer deposits on the leads.

Figure 5. SEM views of one lead (lead 1) after Au layer removal, Part 345.

Top : mag \approx 121X ; center and bottom : mag \approx 420X.

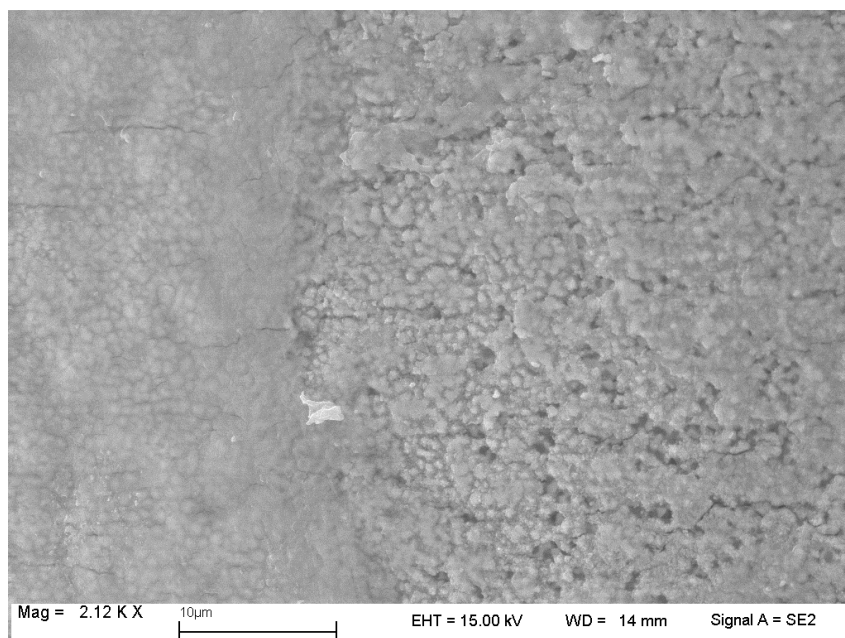
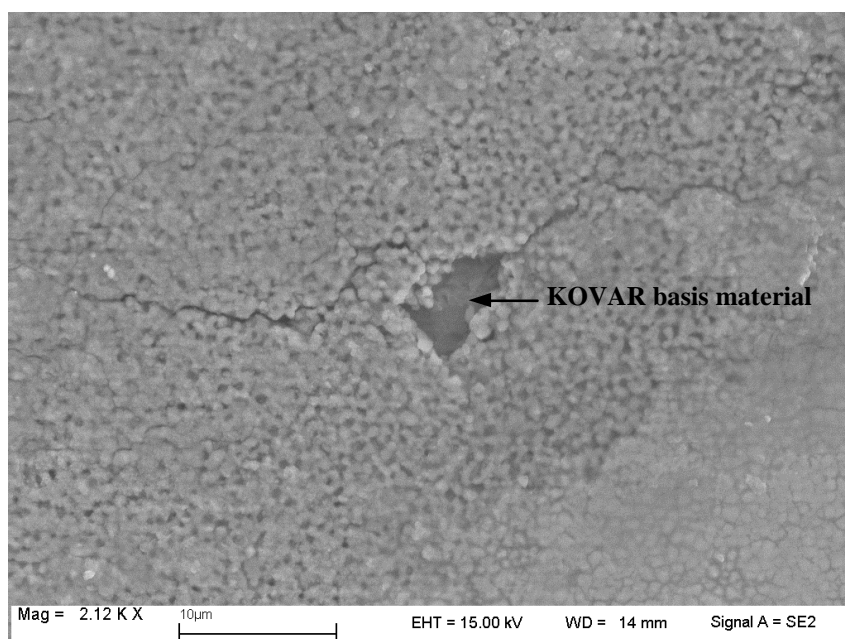
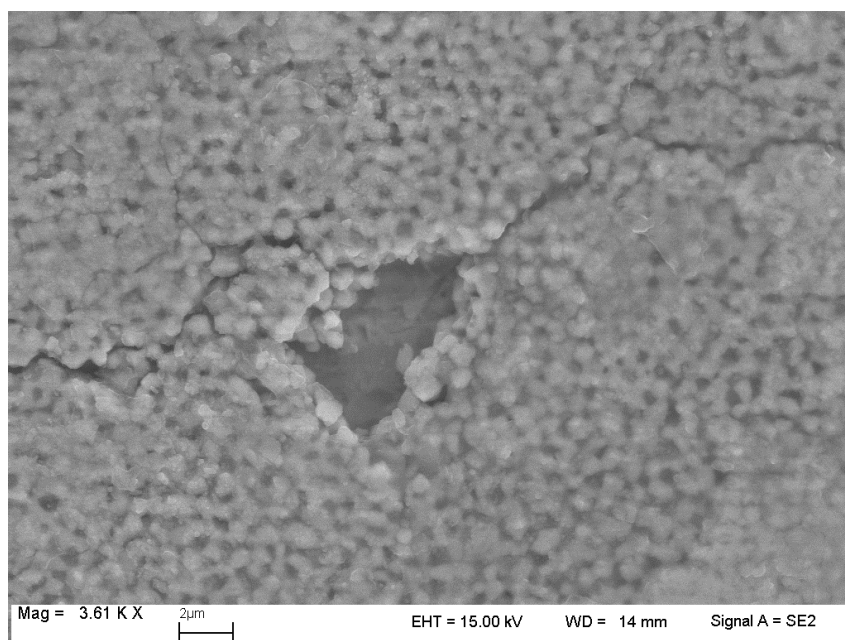
Figure 6. SEM views of one lead (lead 1) after Au layer removal, Part 345.
Top and center : mag \approx 2120X ; bottom : mag \approx 3610X.

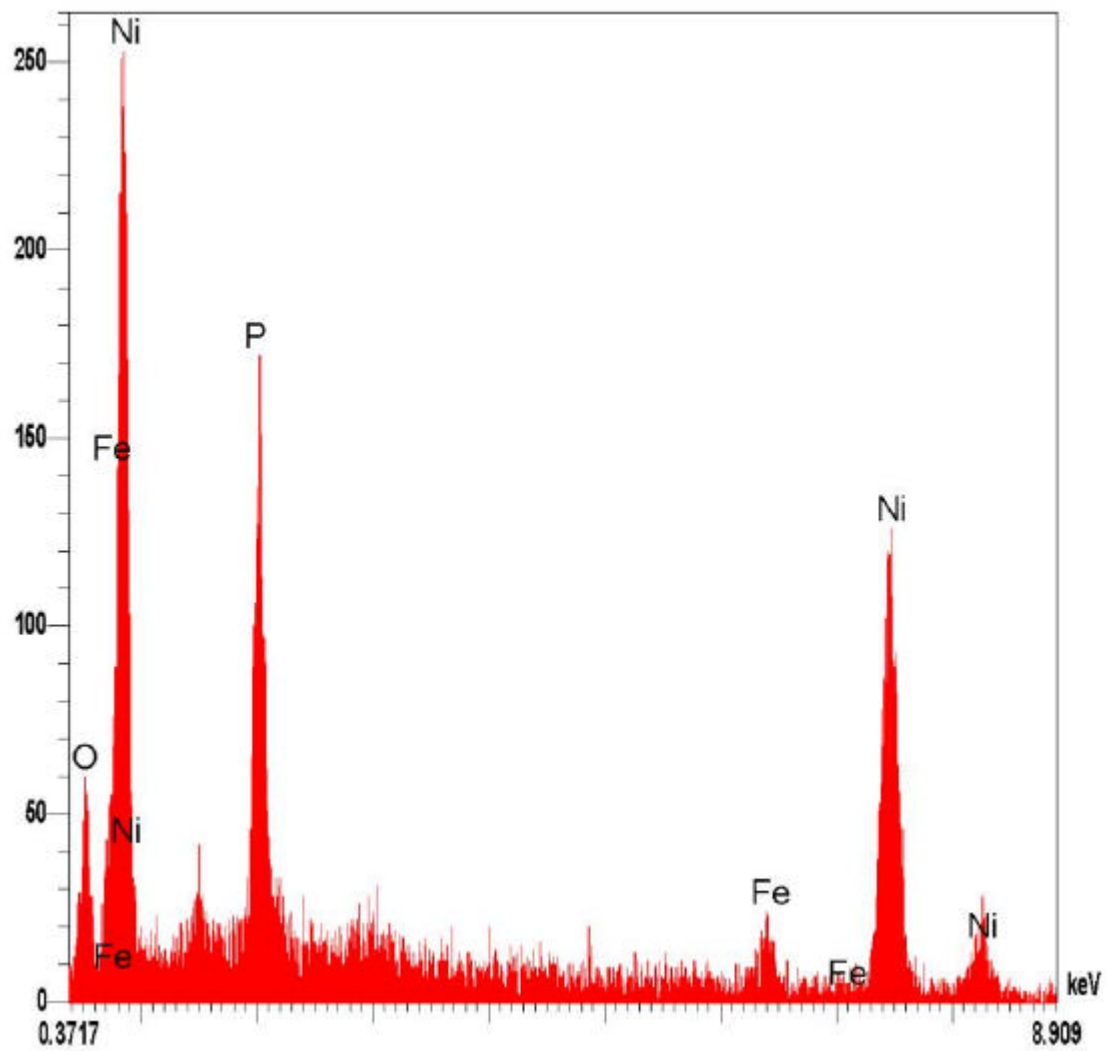
Figure 7. EDX analysis spectrum of the corrosion point.
